**REPORT ON DEMONSTRATION STUDY
CONDUCTED AT
THE BAYONET GOLF COURSE
IN SEASIDE, CALIFORNIA
TO DETERMINE THE COMPATIBILITY
OF RECYCLED WATER
FOR GOLF COURSE IRRIGATION**

April 2006

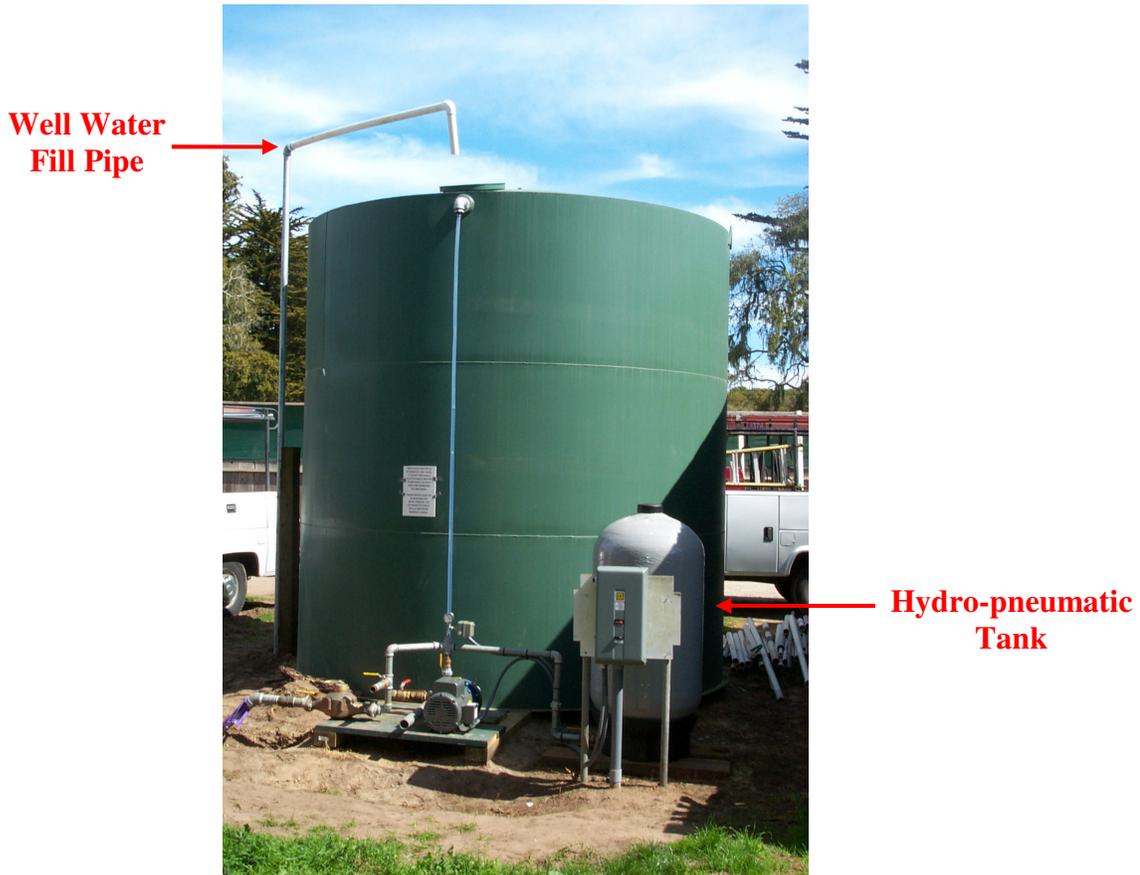
Figure 5 Storage Tank and Pumping Facilities

The required volumes of recycled water from the SVRP were delivered by a 4,000 gallon tanker truck to a 10,000 gallon temporary storage tank and booster pump located at the golf course. A local construction contractor was hired to do the water hauling. These facilities are shown in Figure 5. Programmable irrigation controllers, typical of those used on many golf courses, controlled the irrigation cycles. The individual sprinkler heads each had their own valves, which only opened when sufficient pressure existed in the water supply piping to meet the sprinkler's operational pressure range. This meant that the booster pump had to continuously maintain adequate system pressure. A small hydropneumatic tank, visible at the right in Figure 5, was

provided to avoid frequent pump cycling in order to maintain this pressure. The booster pump was connected to the existing sets of sprinklers that watered the green, turf, and landscaped areas, after those sprinklers had first been disconnected from the well water system.

The tanker truck was equipped with its own pump, and discharged its load of recycled water into the storage tank through a quick-connect fitting on the fill pipe. To provide a back-up water supply in the event the storage tank ran low, a separate fill pipe connected to the well water system was provided. This is visible in Figure 5 as the white plastic pipe that can discharge through an air-gap into the top of the storage tank. This air gap prevented any cross-connection between the recycled water system and the well water system.

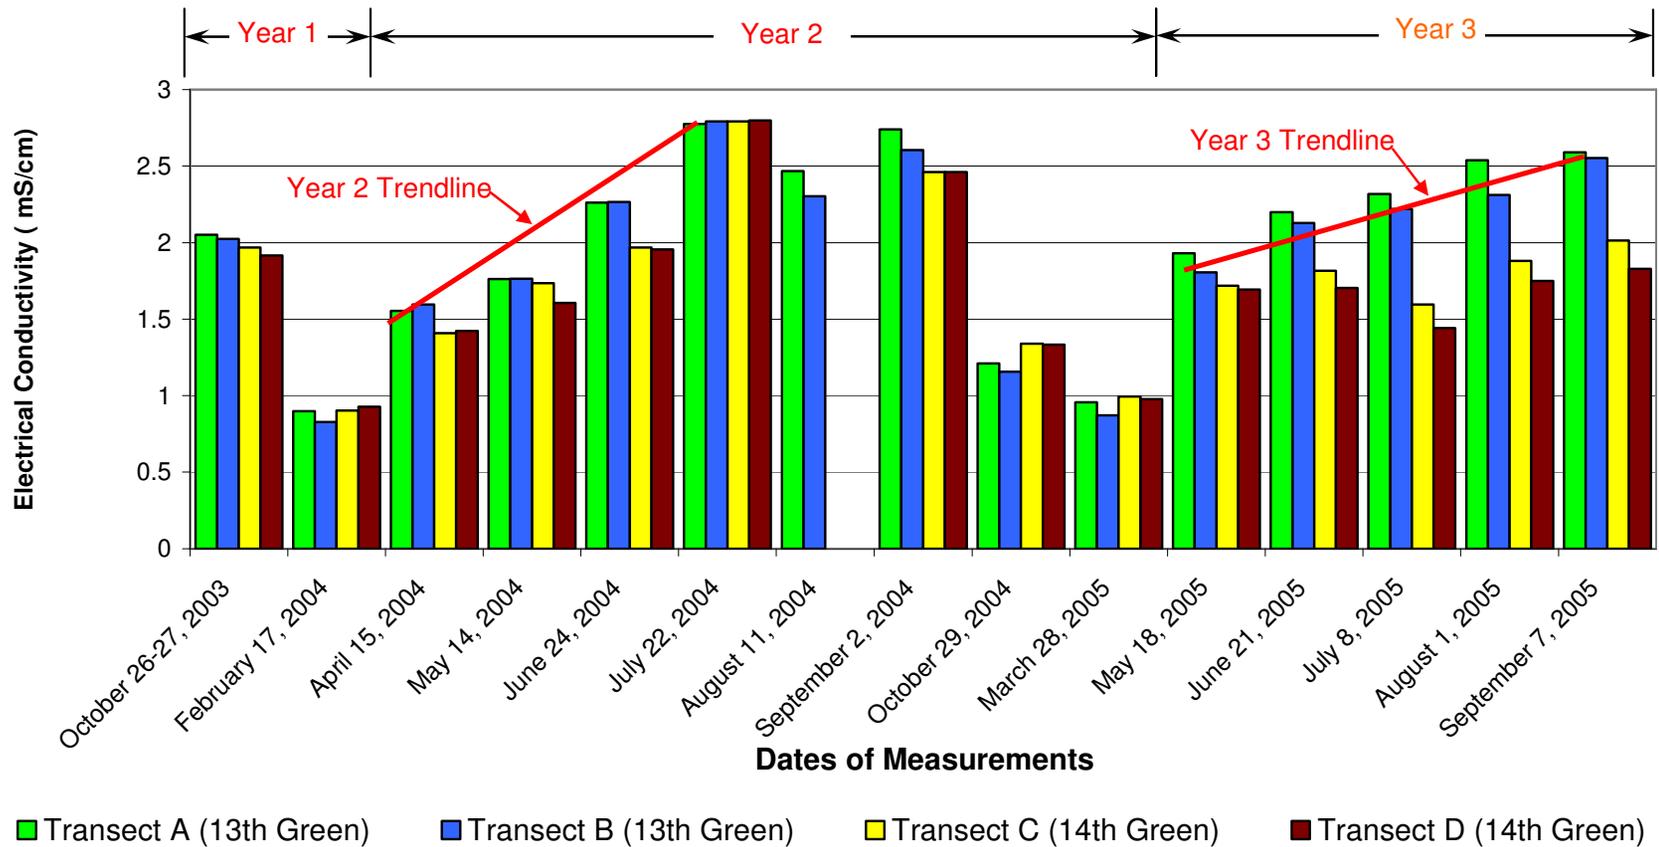
Figure 18

Average Values of Electrical Conductivity Along Each Transect

Year 1: March 31 = First Recycled Water Delivery in 2003 September 22 = Last Recycled Water Delivery in 2003
Year 2: April 30 = First Recycled Water Delivery in 2004 October 15 = Last Recycled Water Delivery in 2004
Year 3: April 29 = First Recycled Water Delivery in 2005 September 22 = Last Recycled Water Delivery in 2005

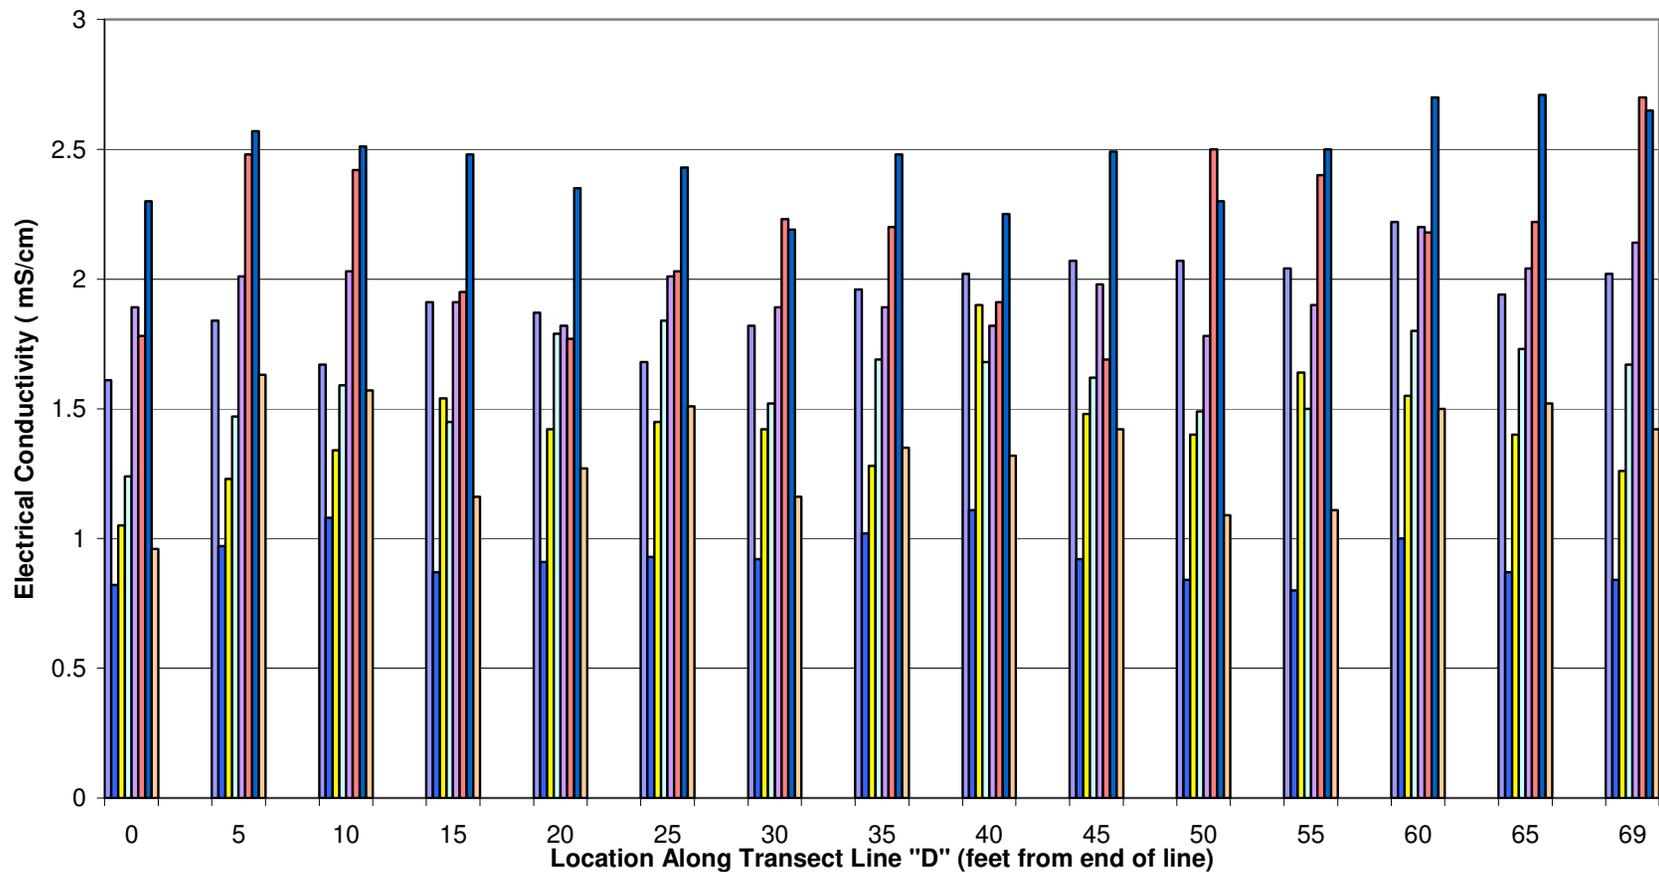
Figure A-7
14th Green Transect "D"
Electrical Conductivity
End of 2003 Irrigation Season and All of 2004 Irrigation Season

■ October 26-27, 2003
■ February 17, 2004
■ April 15, 2004
■ May 14, 2004
■ June 24, 2004
■ July 22, 2004
■ September 2, 2004
■ October 29, 2004

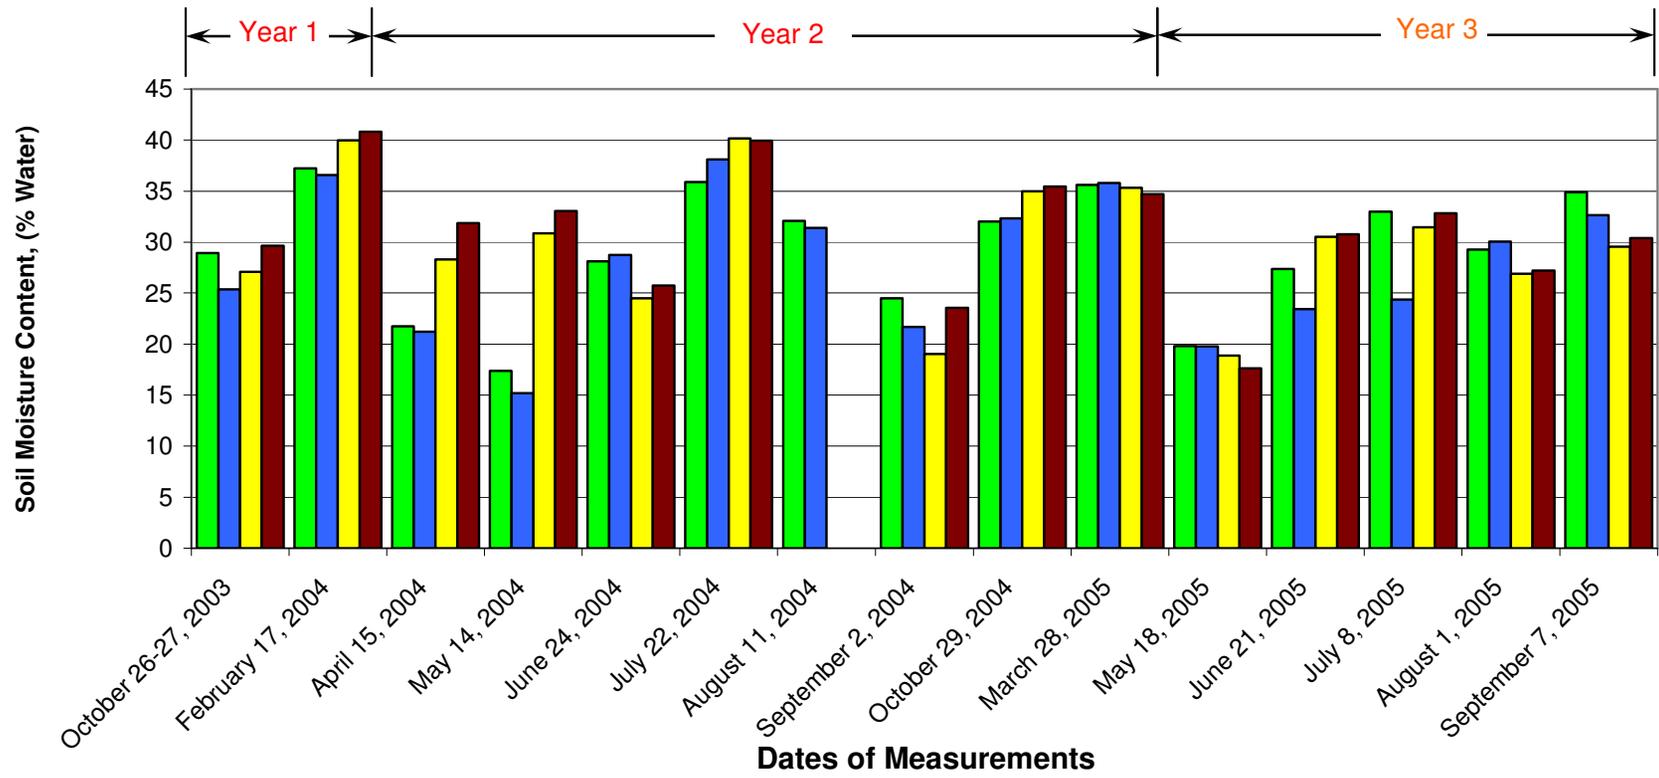
Figure A-9

Average Values of Soil Moisture Content Along Each Transect

Year 1: March 31 = First Recycled Water Delivery in 2003
 Year 2: April 30 = First Recycled Water Delivery in 2004
 Year 3: April 29 = First Recycled Water Delivery in 2005

September 22 = Last Recycled Water Delivery in 2003
 October 15 = Last Recycled Water Delivery in 2004
 September 22 = Last Recycled Water Delivery in 2005

■ Transect A (13th Green)
 ■ Transect B (13th Green)
 ■ Transect C (14th Green)
 ■ Transect D (14th Green)

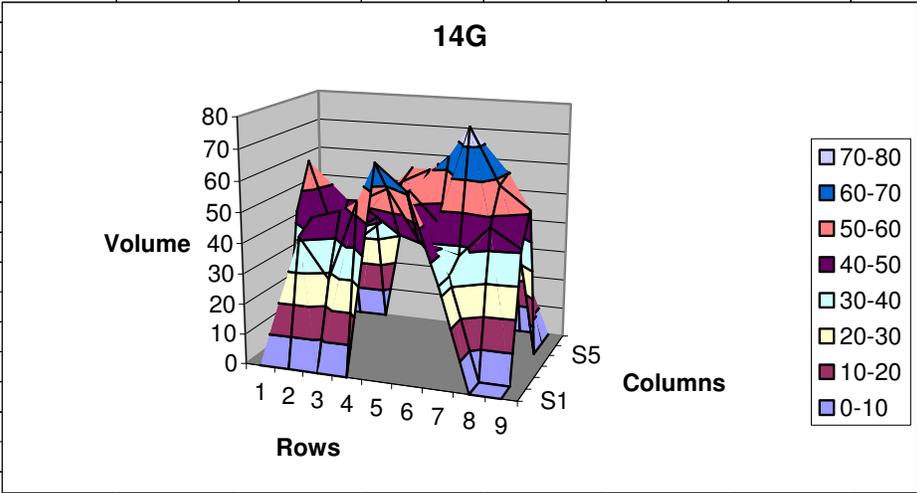
<u>14 Green CC test data</u>								
					Baseline			
Left	0	0	0	44	59	0	0	Right
	0	41	45	29	32	44	0	
	0	28	48	39	35	44	0	
	0	54	49	45	43	52	55	
Baseline	69	59	42	54	53	57	21	Baseline
	61	44	39	44	64	54	35	
	33	33	37	76	66	41	0	
	0	0	47	58	60	34	0	
	0	0	41	51	0	0	0	
				14 Tee
